SUBJECT Varna Harbor Ship and Shore Information DATE DISTR. 30 June 1958

BULGARIAN WARSHIPS AT VARNA AND PORT INFORMATION

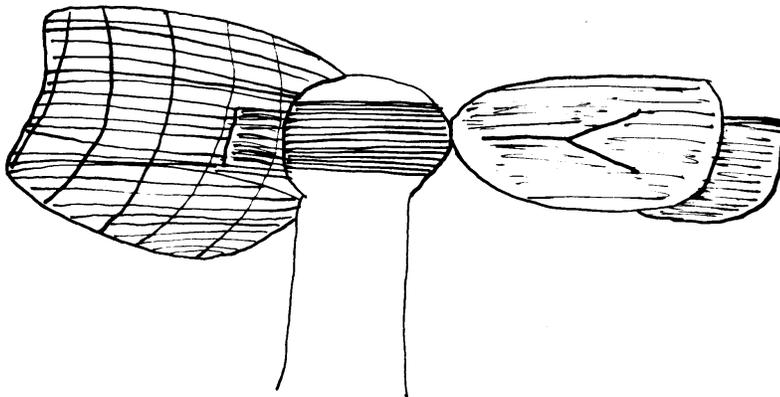
No.

- H Stern to the wall at the East Quay, VARNA.
- Y North Quay, VARNA.
- D Good visibility.
- O Unrestricted.
- F One squat raked funnel.
- I Possibly 801 but not certain.
- L Estimated 300 ft.
- M One tripod mast between funnel and bridge.
- S Flush deck rising to a high bow.
- T Two turrets forward one turret aft calibre unknown.
- A 3 torpedo tubes aft of funnel.
- R See sketch No.1. Fitted on top of mast. [redacted]
- [redacted] rough sketch.
- S Flying Bulgarian ensign.

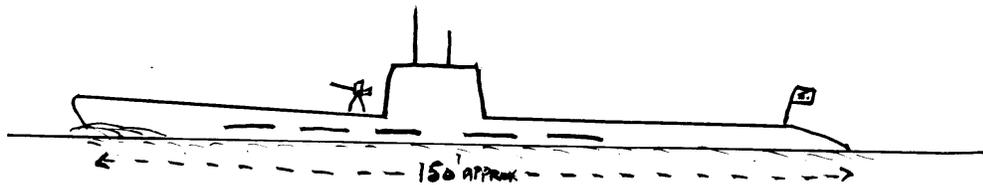
N° 2

3. Two submarines approximately 150ft long were seen berthed at the N.W. end of the Northern side of the Southern Breakwater. A rough sketch No.2 was made of these vessels

They were both flying the Bulgarian ensign.
